**Flood Control Project Maintenance
Levee Inspections**

Maintenance Issue Types Only, Levee Inspection Report By Mile - Fall 2016

Reclamation District No. 0404 Boggs

Waterway	Bank	Unit Miles	Inspection Start/End	Inspector
Unit No. 01 San Joaquin River	Right	2.35	10/06/2016 10/06/2016	Richard Willoughby

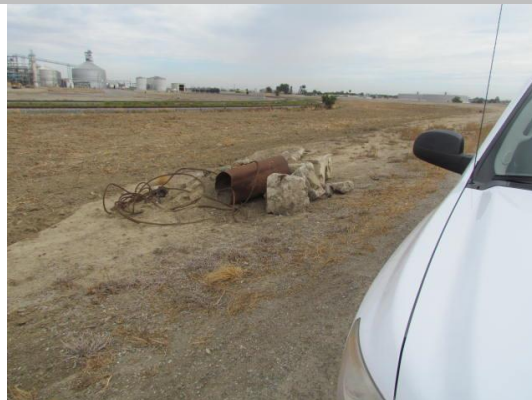
Photo 1 of 1 : FA_2016_RD0404_305_31_20160929_00022.jpg

LM Start	0.13	Rating **	M	Issue No.	31
LM End	0.13	Issue Type +	Ma	Location *	LS
Category	Earthen Levee			GPS Latitude/Longitude	
				Start	End
Item	Encroachments			37.940677 °	37.940677 °
				-121.343790 °	-121.343790 °
DWR ID	DWR_RD0404_01_s_2015_31				
Comment Code					
MA : Material					
Inspector Comment					
Remove the large concrete blocks from landward slope.

Looking southeast at concrete blocks on landward slope.

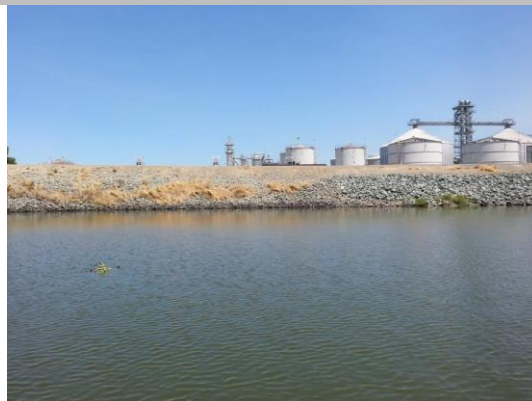
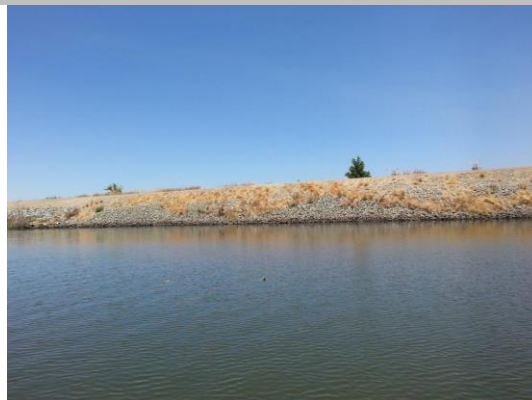
07/25/2016: No significant change observed.
 06/24/2015: No significant change observed.
 06/19/2014: No significant change observed.
 08/13/2013: No significant change at this site.
 08/7/2012: The erosion is next to a repaired site and approximately 400 feet downstream of a river bend. There are broken concretes at the upper levee slope, but not visible at the levee toe or lower slope. Likely the protection concrete blocks have been washed away. [2016 Site ID:RD0404U01RM41.11]

Front view of the site.

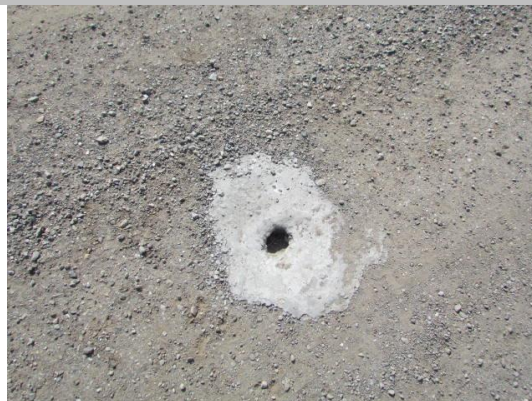
Photo 1 of 4 : FA_2016_RD0404_305_5_20160929_00004.jpg

LM Start	0.43	Rating **	M	Issue No.	5
LM End	0.43	Issue Type +	Ma	Location *	CR
Category	Earthen Levee			GPS Latitude/Longitude	
				Start	End
Item	Animal Control			37.939635 °	37.939635 °
				-121.339063 °	-121.339063 °
DWR ID	DWR_RD0404_01_s_2013_5				
Comment Code					
A3 : No rodents visible, but rodent burrows visible; need to backfill and compact or grout burrows.					
Inspector Comment					
District grouted hole, and the deficiency still exist.

Looking at partialled grouted rodent hole on levee crown (Fall 2014).

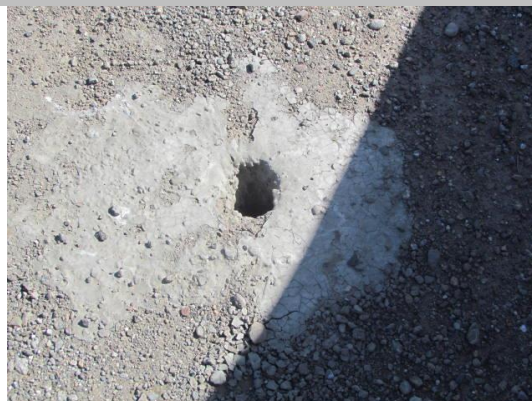
Photo 2 of 4 : FA_2016_RD0404_305_5_20160929_00005.jpg

Looking at partially grouted rodent hole on levee crown

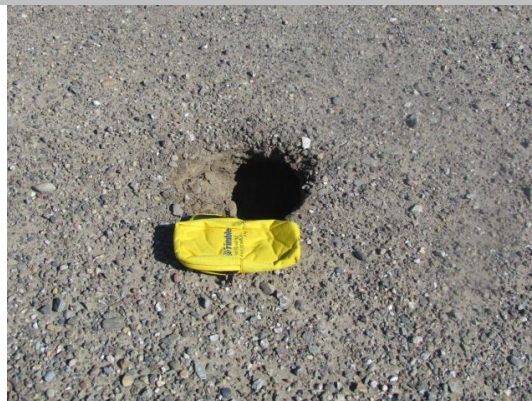
Photo 3 of 4 : FA_2016_RD0404_305_5_20160929_00006.jpg

Looking at rodent hole on levee crown.

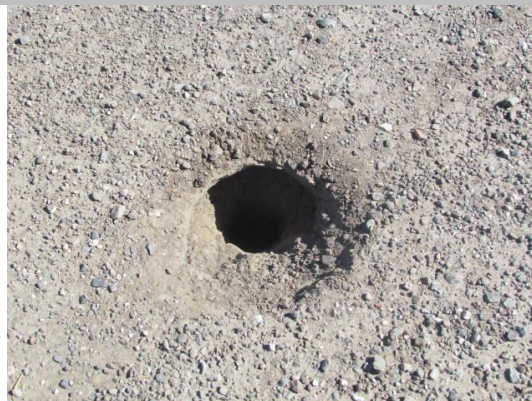
Photo 4 of 4 : FA_2016_RD0404_305_5_20160929_00007.jpg

Looking at one of several rodent holes on levee crown.

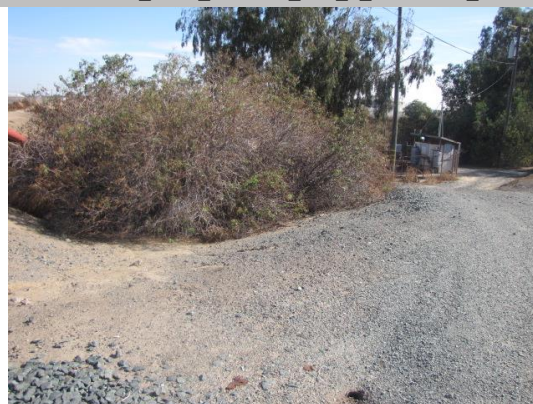
Photo 1 of 1 : FA_2016_RD0404_305_7_20160929_00008.jpg

LM Start	0.75	Rating **	M	Issue No.	7
LM End	0.75	Issue Type +	Ma	Location *	LS
Category	Earthen Levee			GPS Latitude/Longitude	
				Start	End
Item	Vegetation			37.937758°	37.937758°
				-121.334149°	-121.334149°
DWR ID	DWR_RD0404_01_s_2012_7				
Comment Code					
V4 : Elderberries are blocking visibility and flood fight capability.					
Inspector Comment

Looking southeast at elderberry on landside slope.

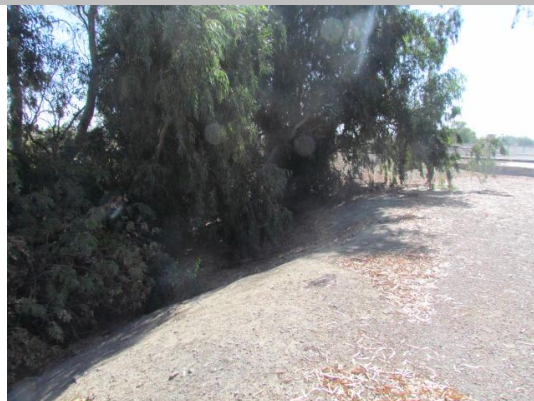
Photo 1 of 1 : FA_2016_RD0404_305_8_20160929_00009.jpg

LM Start	0.78	Rating **	M	Issue No.	8
LM End	0.78	Issue Type +	Ma	Location *	LS
Category	Earthen Levee			GPS Latitude/Longitude	
				Start	End
Item	Trim / Thin Trees			37.937395°	37.937395°
				-121.333883°	-121.333883°
DWR ID	DWR_RD0404_01_s_2013_8				
Comment Code					
T1 : Trim trees to at least five feet above ground level.					
Inspector Comment					
Trees are blocking view of the slope.

Looking southeast at dense trees on landward slope and toe.

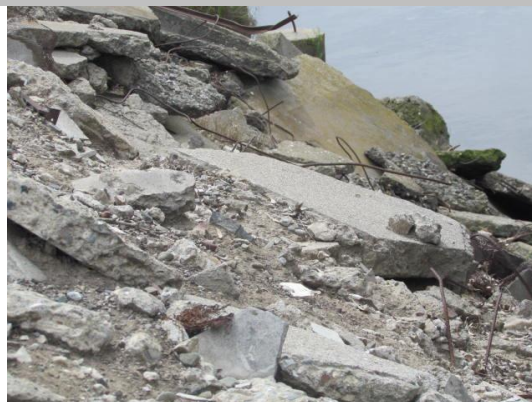
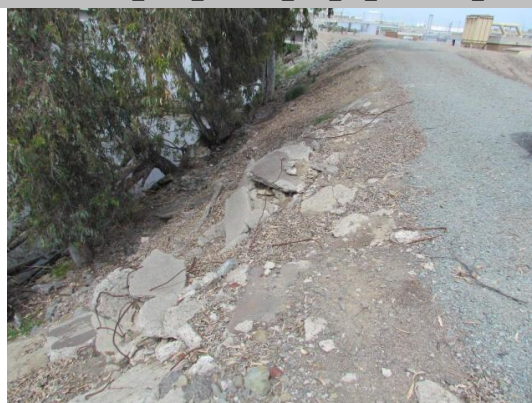
LM Start	1.15	Rating **	M	Issue No.	38
LM End	1.15	Issue Type +	Ma	Location *	WS
Category	Earthen Levee			GPS Latitude/Longitude	
				Start	End
Item	Riprap Revetments			37.934492 °	37.934492 °
				-121.328570 °	-121.328570 °
DWR ID	DWR_RD0404_01_s_2016_38				
Comment Code					
Inspector Comment					
Concrete with rebar on waterward shoulder and slope.

Looking southwest at concrete rubble with rebar on waterward slope.

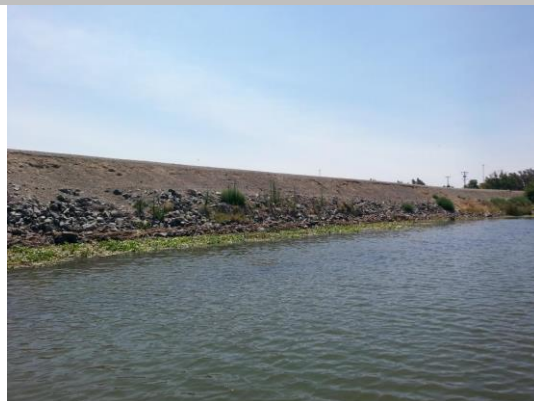
Photo 1 of 2 : SJR2016_RD0404U01RM42.02_1.jpg

LM Start	1.44	Rating **	M	Issue No.	41
LM End	1.46	Issue Type +	Ma	Location *	WS
Category	Supplemental			GPS Latitude/Longitude	
				Start	End
Item	DWR Erosion Survey			37.930450 °	37.930450 °
				-121.327450 °	-121.327450 °
DWR ID					
Comment Code					
Inspector Comment					
07/25/2016: No significant change observed.					
06/24/2015: No significant change observed.					
06/19/2014: A series of scarp erosions have been found on the lower levee slope and at the levee toe. [2016 Site ID:RD0404U01RM42.02]

Downstream view of the erosion.

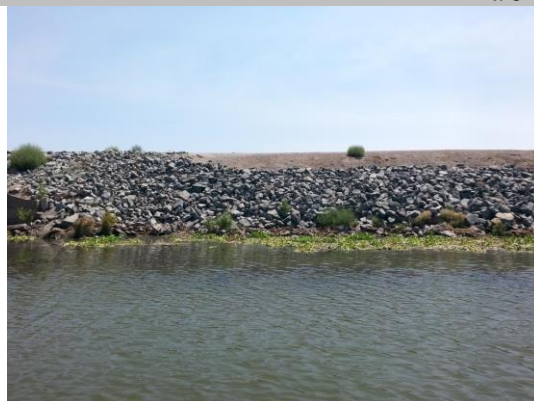
Photo 2 of 2 : SJR2016_RD0404U01RM42.02_3.jpg

Close view of the erosion. The upstream end of the site is protected by riprap revetment.

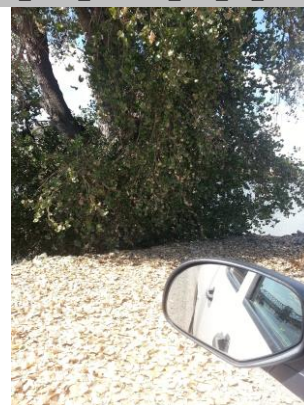
Photo 1 of 1 : FA_2016_RD0404_305_27_20161007_00070.jpg

LM Start	1.50	Rating **	U	Issue No.	27
LM End	1.50	Issue Type +	Ma	Location *	WS
Category	Earthen Levee			GPS Latitude/Longitude	
				Start	End
Item	Trim / Thin Trees			37.896544°	37.896544°
				-121.327121°	-121.327121°
DWR ID	DWR_RD0404_01_f_2016_27				
Comment Code					
T2 : Thin trees to allow visibility of the ground and room to flood fight.					
Inspector Comment

Looking west at untrimmed trees on waterward slope.

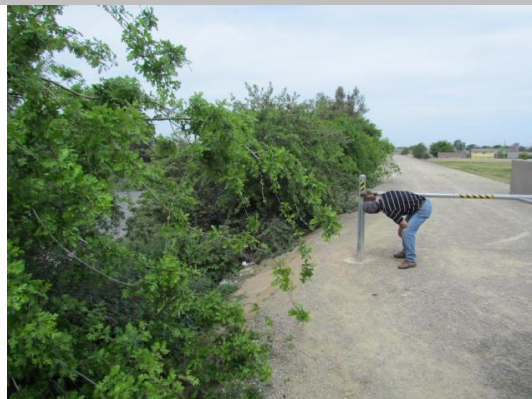
Photo 1 of 2 : FA_2016_RD0404_305_29_20160929_00020.jpg

LM Start	1.70	Rating **	A/W	Issue No.	29
LM End	1.77	Issue Type +	Ma	Location *	WS
Category	Earthen Levee			GPS Latitude/Longitude	
				Start	End
Item	Trim / Thin Trees			37.927517 °	37.926632 °
				-121.325515 °	-121.324868 °
DWR ID	DWR_RD0404_01_s_2015_29				
Comment Code					
T1 : Trim trees to at least five feet above ground level.					
Inspector Comment					
Dense untrimmed trees on waterward slope. Army Corp veg site.Tree and woody vegetation planted by the DWR but not being maintain according to agreement.

Looking north at dense vegetation on waterward slope.

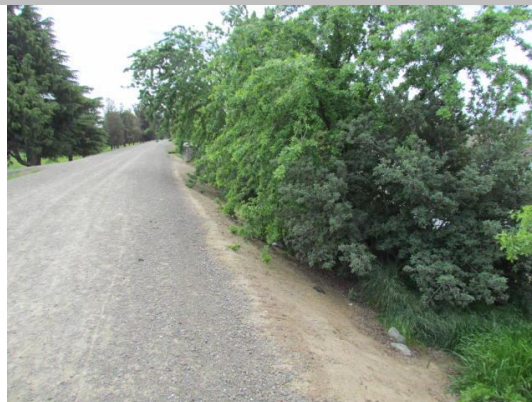
Photo 2 of 2 : FA_2016_RD0404_305_29_20160929_00021.jpg

Looking south at dense vegetation on waterward slope.

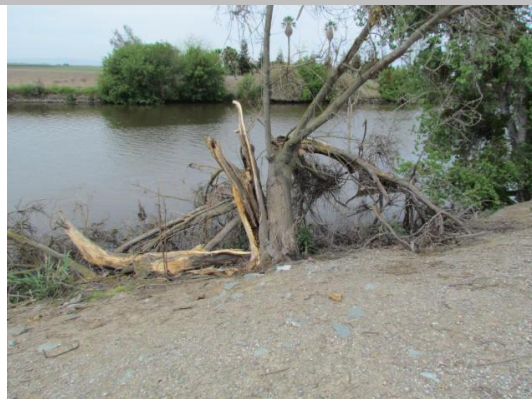
Photo 1 of 1 : FA_2016_RD0404_305_33_20160929_00023.jpg

LM Start	2.00	Rating **	U	Issue No.	33
LM End	2.00	Issue Type +	Ma	Location *	WS
Category	Earthen Levee			GPS Latitude/Longitude	
				Start	End
Item	Encroachments			37.923673 °	37.923673 °
				-121.323015 °	-121.323015 °
DWR ID	DWR_RD0404_01_s _ 2016_33				
Comment Code					
TR : Tree or limb					
Inspector Comment					
Dead tree on waterward slope

Looking west at dead tree on waterward slope.

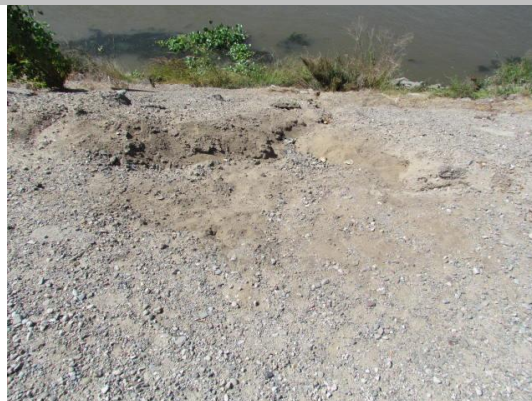
Photo 1 of 2 : FA_2016_RD0404_305_16_20160929_00014.jpg

LM Start	2.01	Rating **	M	Issue No.	16
LM End	2.01	Issue Type +	Ma	Location *	WS
Category	Earthen Levee			GPS Latitude/Longitude	
				Start	End
Item	Slope Stability			37.923470°	37.923470°
				-121.322978°	-121.322978°
DWR ID	DWR_RD0404_01_f_2013_16				
Comment Code					
S2 : Repair the levee slope damaged by foot traffic and prevent access where possible.					
Inspector Comment					
Slope damage due to foot traffic.

Looking west at slope damage due to foot traffic.

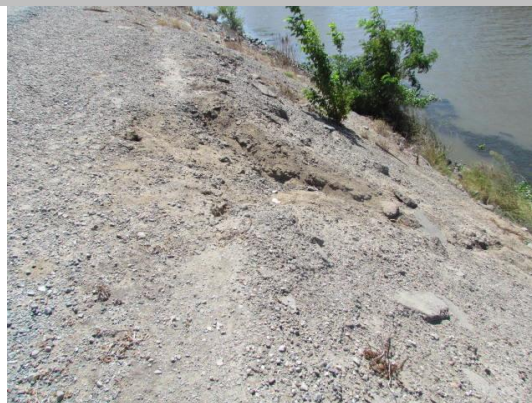
Photo 2 of 2 : FA_2016_RD0404_305_16_20160929_00015.jpg

Looking southwest at slope damage due to foot traffic.

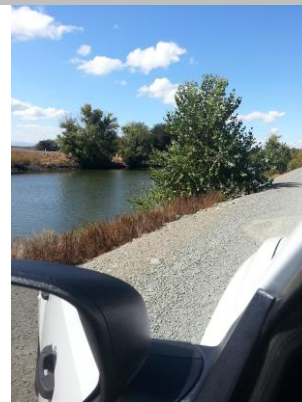
Photo 1 of 1 : FA_2016_RD0404_305_13_20161007_00071.jpg

LM Start	2.08	Rating **	M	Issue No.	13
LM End	2.08	Issue Type +	Ma	Location *	WS
Category	Earthen Levee			GPS Latitude/Longitude	
				Start	End
Item	Trim / Thin Trees			37.922669 °	37.922669 °
				-121.322272 °	-121.322272 °
DWR ID	DWR_RD0404_01_f_2012_13				
Comment Code					
T1 : Trim trees to at least five feet above ground level.					
Inspector Comment

Looking northwest at untrimmed tree on waterward slope.

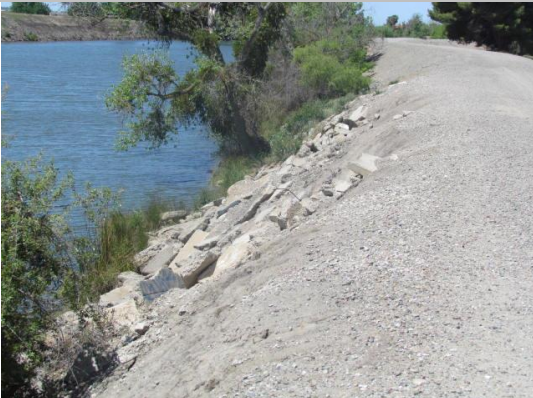
Photo 1 of 2 : FA_2016_RD0404_305_23_20160929_00016.jpg

Looking west at concrete rip rap with rebar. (Spring 2015)

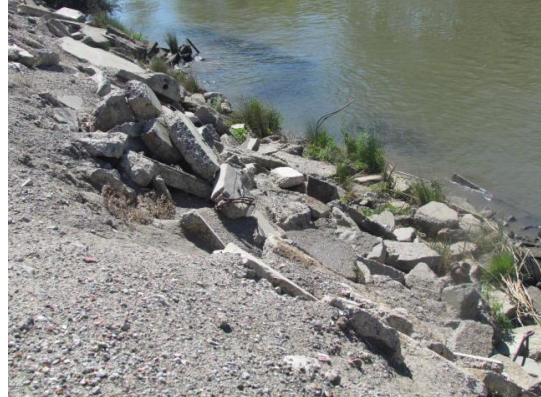
Photo 2 of 2 : FA_2016_RD0404_305_23_20160929_00017.jpg

LM Start	2.33	Rating **	M	Issue No.	23 (cont)
LM End	2.35	Issue Type +	Ma	Location *	WS
Category	Earthen Levee			GPS Latitude/Longitude	
				Start	End
Item	Riprap Revetments			37.920488°	37.920338°
				-121.318630°	-121.318435°
DWR ID	DWR_RD0404_01_s_2013_23				
Comment Code					
Inspector Comment					
Remove rebar from existing concrete rip rap on waterward slope.

Looking southwest at concrete rip rap with rebar.

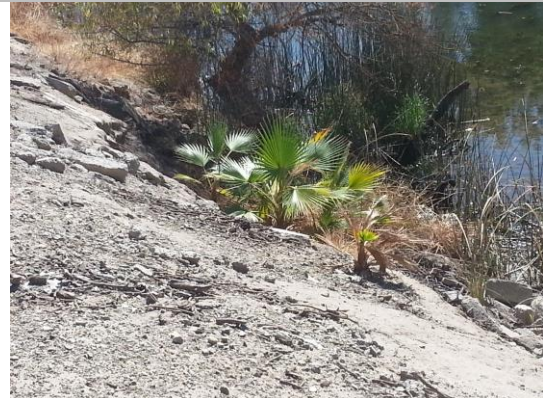
Photo 1 of 1 : FA_2016_RD0404_306_14_20161007_00031.jpg

LM Start	0.14	Rating **	U	Issue No.	14
LM End	0.14	Issue Type +	Ma	Location *	WS
Category	Earthen Levee			GPS Latitude/Longitude	
				Start	End
Item	Erosion / Bank Caving			37.918875 °	37.918875 °
				-121.316587 °	-121.316587 °
DWR ID	DWR_RD0404_02_f_2016_14				
Comment Code					
E2 : Schedule repair of erosion site prior to the next inspection.					
Inspector Comment

Looking southeast at erosion on waterward slope.

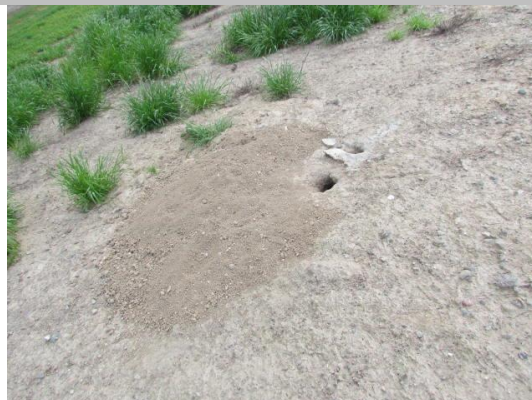
Photo 1 of 2 : FA_2016_RD0404_306_21_20160929_00006.jpg

LM Start	0.68	Rating **	U	Issue No.	21
LM End	0.94	Issue Type +	Ma	Location *	LS
Category	Earthen Levee			GPS Latitude/Longitude	
				Start	End
Item	Animal Control			37.919245 °	37.916652 °
				-121.307705 °	-121.305085 °
DWR ID	DWR_RD0404_02_s_2016_21				
Comment Code					
A1 : Exterminate rodents and backfill and compact or grout burrows.					
Inspector Comment					
Large holes noted on landward slope.

Looking northeast at large roden hole on landward slope.

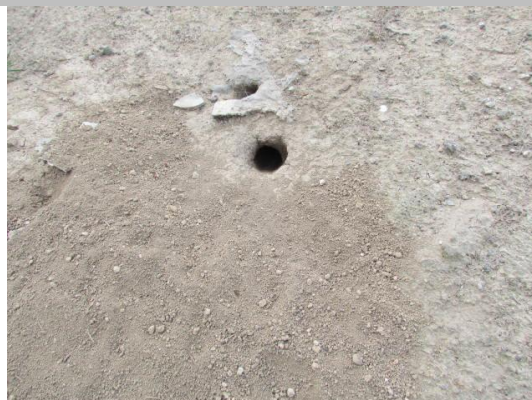
Photo 2 of 2 : FA_2016_RD0404_306_21_20160929_00007.jpg

Looking east at large rodent hole on landward slope.

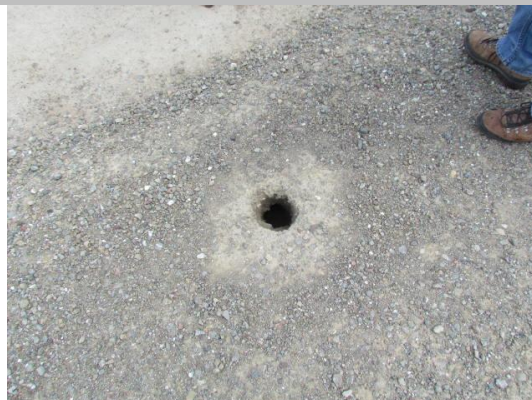
Photo 1 of 2 : FA_2016_RD0404_306_20_20160929_00004.jpg

Looking at rodent hole on levee crown.

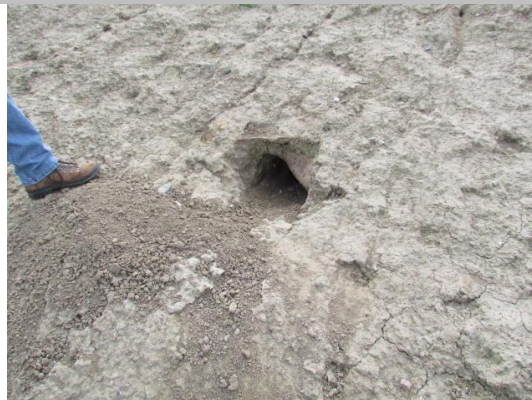
Photo 2 of 2 : FA_2016_RD0404_306_20_20160929_00005.jpg

Looking at rodent hole on landward slope.

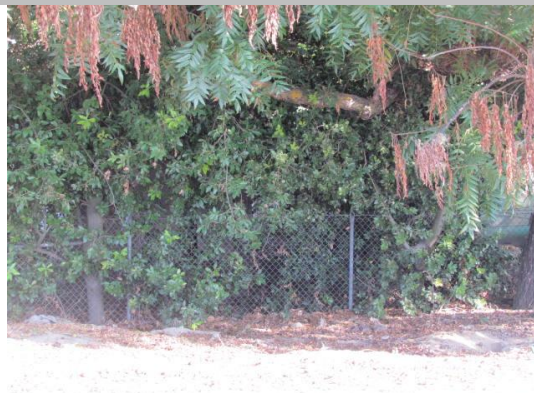
Photo 1 of 4 : FA_2016_RD0404_306_67_20160929_00008.jpg

Looking northeast at dense vegetation inside fenced area near pump station on landside toe.

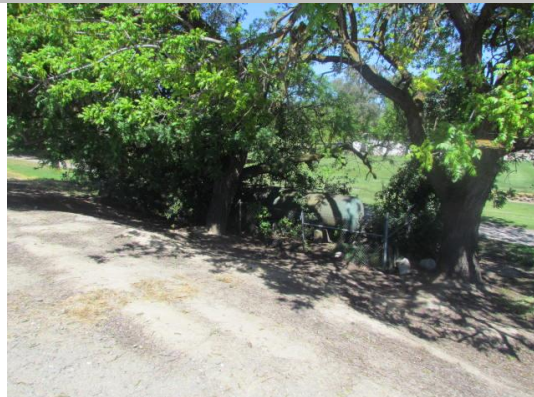
Photo 2 of 4 : FA_2016_RD0404_306_67_20160929_00009.jpg

Looking north at dense vegetation on landward toe around propane tank.

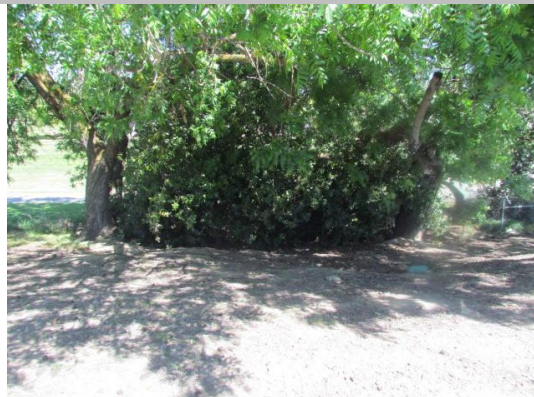
Photo 3 of 4 : FA_2016_RD0404_306_67_20160929_00010.jpg

Looking northeast at dense vegetation on landward toe. (Spring 2013)

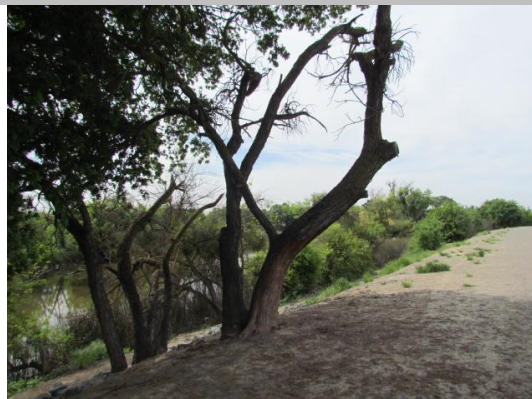
Photo 1 of 2 : FA_2016_RD0404_306_18_20160929_00003.jpg

Looking east at dead trees on waterward slope.

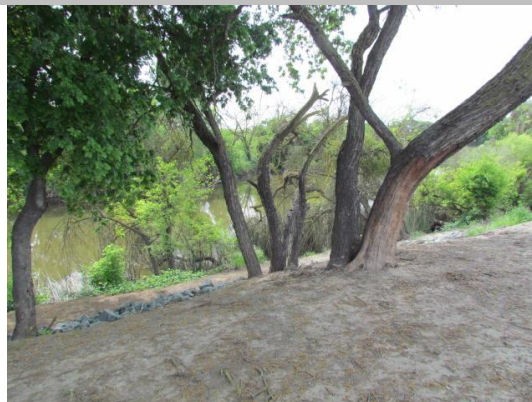
Photo 2 of 2 : FA_2016_RD0404_306_18_20160929_00002.jpg

Looking at close up view of dead trees on waterward slope.
